2D ELECTRICAL RESISTIVITY IMAGING INVESTIGATION ON CAUSES OF ROAD FAILURE ALONG KUTIGI STREET, MINNA, NORTH CENTRAL, NIGERIA

¹Federal University of Technology Minna | Department of Physics | Minna | Nigeria |

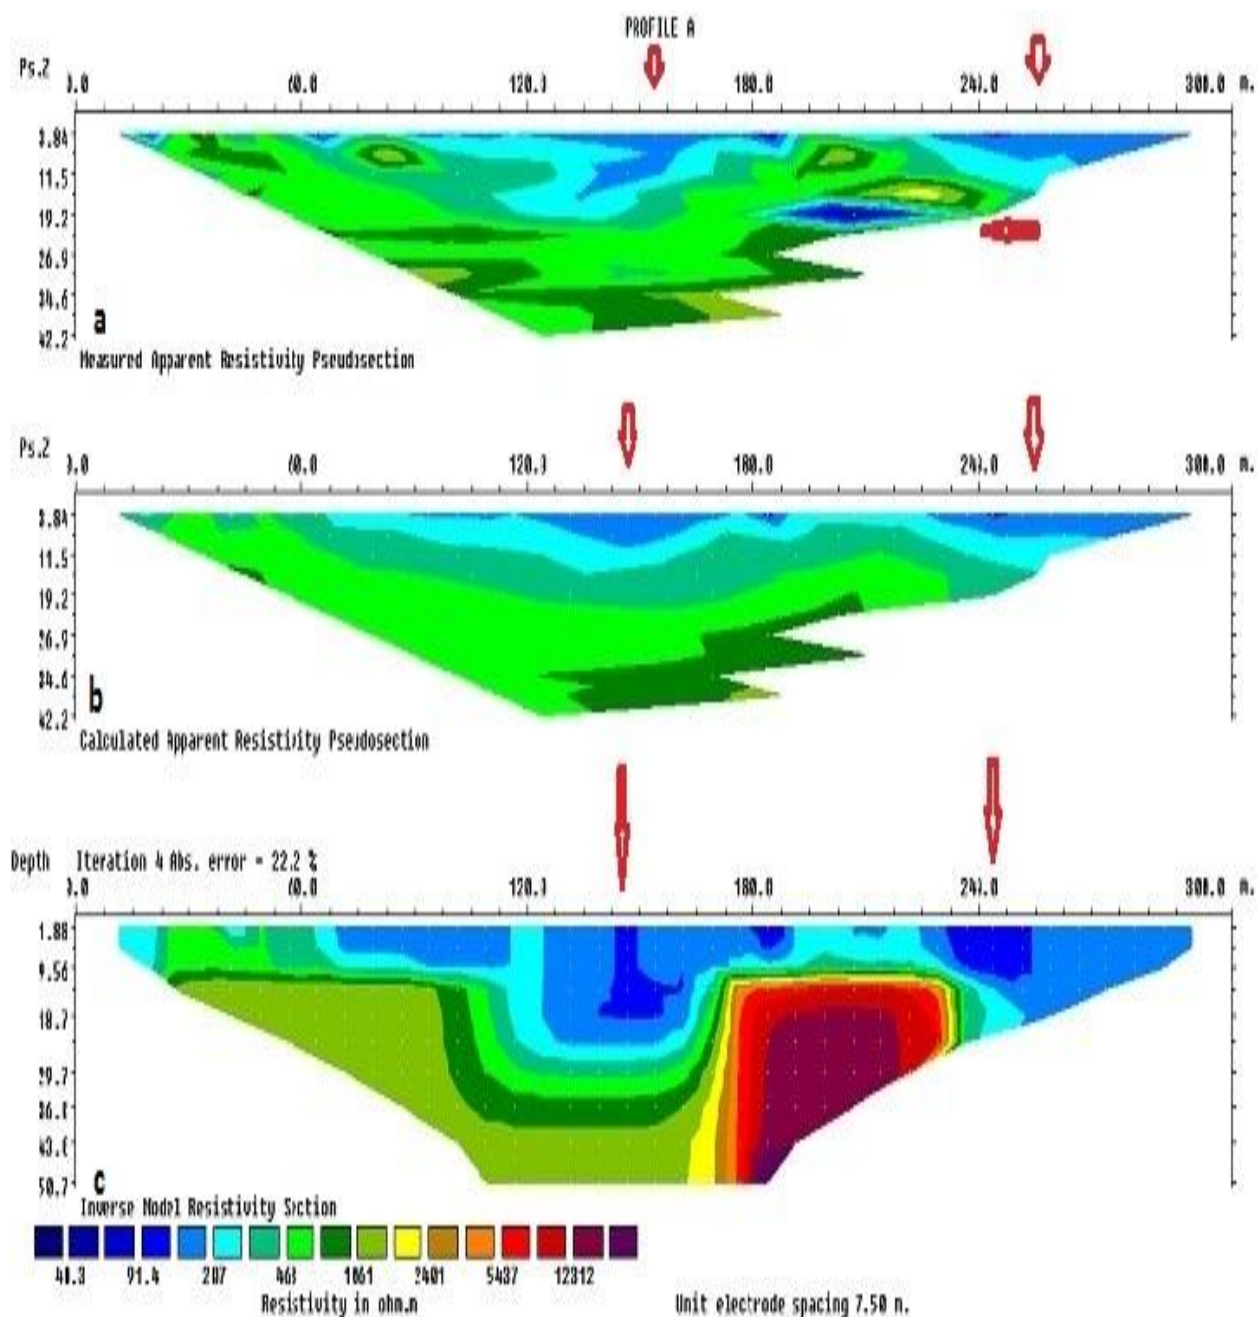
Figure 3: Pseudo-section plots showing (a) measured apparent resistivity of profile A (b) calculated apparent resistivity of profile A (c) inverse model resistivity section of profile A.

Figure 3(a) represents the Pseudo-section from the apparent resistivity measurement along profile A. It shows a low resistivity value ranging from $9.75 \Omega\text{m}$ – $91.40 \Omega\text{m}$, between two major regions at distances ranging from 120 m – 190 m and 225 m – 300 m along the transverse to a depth of 3.84 m – 19.20 m and 3.84 m – 11.50 m respectively. Figure 3(b) is a Pseudo-section generated from the calculated apparent resistivity values showing relatively low resistivity values in two region along the traverse similar to the position of the result obtained in figure 3(a).

Figure 3(c) is the inverse model which reveals the resistivity sections along the transverse. Two distinctive zones were observed with low resistivity values along profile A. At a distance between 122.5 m – 130.0 m along profile A, low resistivity values ranging from $19.25 \Omega\text{m}$ – $107.0 \Omega\text{m}$ to a depth of 19.2 m from the top soil were observed. Also at distances between 232.50 m – 252.50 m , low resistivity values ranging from $9.25 \Omega\text{m}$ – $115.30 \Omega\text{m}$ to a depth of 11.50 m from the surface of the profile was observed.

Low resistivity values, less than 200 Ωm observed in regions of both profiles comprises of expansive clay and sandy clay materials which have the tendency of absorbing water [6]. These makes them to swell and eventually collapse under imposed wheel load stress which leads to failure. The stable regions of the road have considerable high resistivity value greater than 200 Ωm , mostly laterite materials [6].

Geo-electrical attributes of the road subsurface along Kutigi Street were examined to ascertain the causes of its failure. In profile A Figure 3(c), low resistivity values were observed ranging from 9.25 Ωm – 115.30 Ωm to a depth of 11.25 m from the topsoil along the profile. In profile B, low resistivity values were observed in Figure 4(c) ranging from 5.20 Ωm – 25.6 Ωm to a depth of 11.25 m from the topsoil along the profile.

Other contributing factors such as inadequate drainage system, lack of maintenance, thin pavement coating of the road, and poor construction materials are factors resulting to eventual failure of the road. Regions of the road with sandy and clayey materials should be excavated from the subsurface to a depth of 4 m – 6 m from the top soil of the road and replaced with competent fill materials.

Adequate drainage system should be provided for the road to avoid the long time suspension of water on road pavement as this weakens the molecular force holding the particles of the pavement together.
