## 2D ELECTRICAL RESISTIVITY IMAGING INVESTIGATION ON CAUSES OF ROAD FAILURE ALONG KUTIGI STREET, MINNA, NORTH CENTRAL, NIGERIA

| Joshua Ebuga Peter <sup>1\*</sup> | Rafiu A.A.<sup>1</sup> | Udensi E.E.<sup>1</sup> | Salako K. A.<sup>1</sup> | Alhassan U. D.<sup>1</sup> | and | Adetona A.A.<sup>1</sup> |

<sup>1</sup>Federal University of Technology Minna | Department of Physics | Minna | Nigeria |

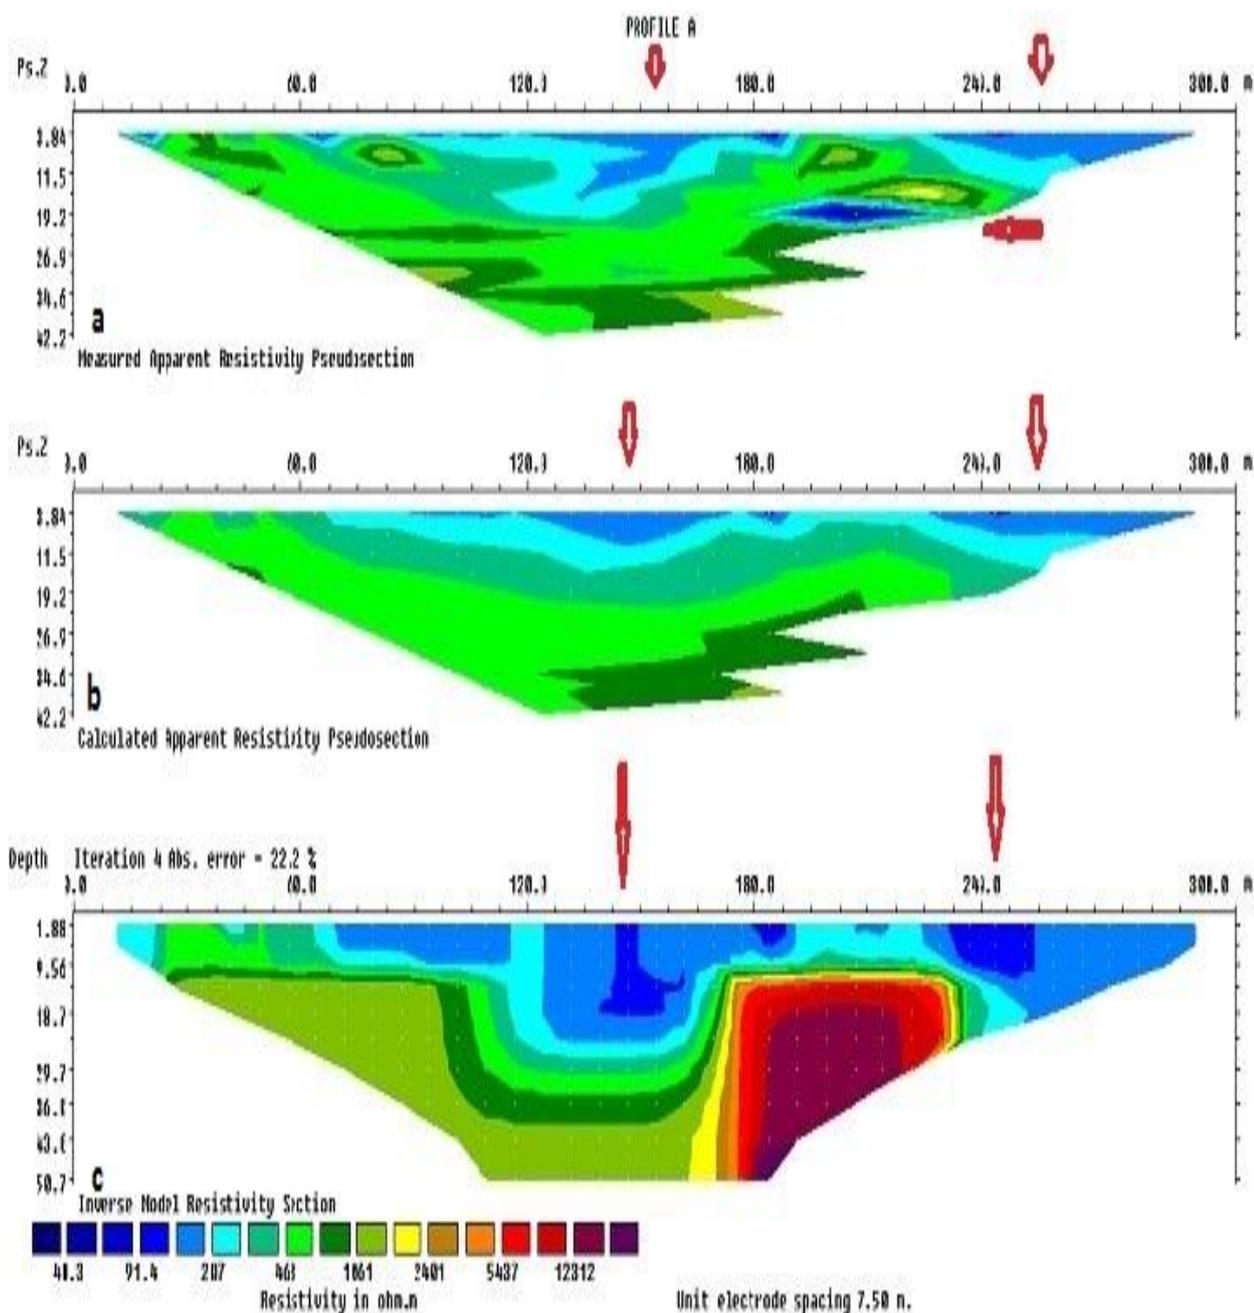
**Figure 3:** Pseudo-section plots showing (a) measured apparent resistivity of profile A (b) calculated apparent resistivity of profile A (c) inverse model resistivity section of profile A.

Figure 3(a) represents the Pseudo-section from the apparent resistivity measurement along profile A. It shows a low resistivity value ranging from  $9.75 \Omega\text{m}$  –  $91.40 \Omega\text{m}$ , between two major regions at distances ranging from  $120 \text{ m}$  –  $190 \text{ m}$  and  $225 \text{ m}$  –  $300 \text{ m}$  along the transverse to a depth of  $3.84 \text{ m}$  –  $19.20 \text{ m}$  and  $3.84 \text{ m}$  –  $11.50 \text{ m}$  respectively. Figure 3(b) is a Pseudo-section generated from the calculated apparent resistivity values showing relatively low resistivity values in two region along the traverse similar to the position of the result obtained in figure 3(a).

Figure 3(c) is the inverse model which reveals the resistivity sections along the transverse. Two distinctive zones were observed with low resistivity values along profile A. At a distance between  $122.5 \text{ m}$  –  $130.0 \text{ m}$  along profile A, low resistivity values ranging from  $19.25 \Omega\text{m}$  –  $107.0 \Omega\text{m}$  to a depth of  $19.2 \text{ m}$  from the top soil were observed. Also at distances between  $232.50 \text{ m}$  –  $252.50 \text{ m}$ , low resistivity values ranging from  $9.25 \Omega\text{m}$  –  $115.30 \Omega\text{m}$  to a depth of  $11.50 \text{ m}$  from the surface of the profile was observed.

Low resistivity values, less than 200  $\Omega\text{m}$  observed in regions of both profiles comprises of expansive clay and sandy clay materials which have the tendency of absorbing water [6]. These makes them to swell and eventually collapse under imposed wheel load stress which leads to failure. The stable regions of the road have considerable high resistivity value greater than 200  $\Omega\text{m}$ , mostly laterite materials [6].

Geo-electrical attributes of the road subsurface along Kutigi Street were examined to ascertain the causes of its failure. In profile A Figure 3(c), low resistivity values were observed ranging from 9.25  $\Omega\text{m}$  – 115.30  $\Omega\text{m}$  to a depth of 11.25 m from the topsoil along the profile. In profile B, low resistivity values were observed in Figure 4(c) ranging from 5.20  $\Omega\text{m}$  – 25.6  $\Omega\text{m}$  to a depth of 11.25 m from the topsoil along the profile.

Other contributing factors such as inadequate drainage system, lack of maintenance, thin pavement coating of the road, and poor construction materials are factors resulting to eventual failure of the road. Regions of the road with sandy and clayey materials should be excavated from the subsurface to a depth of 4 m – 6 m from the top soil of the road and replaced with competent fill materials.

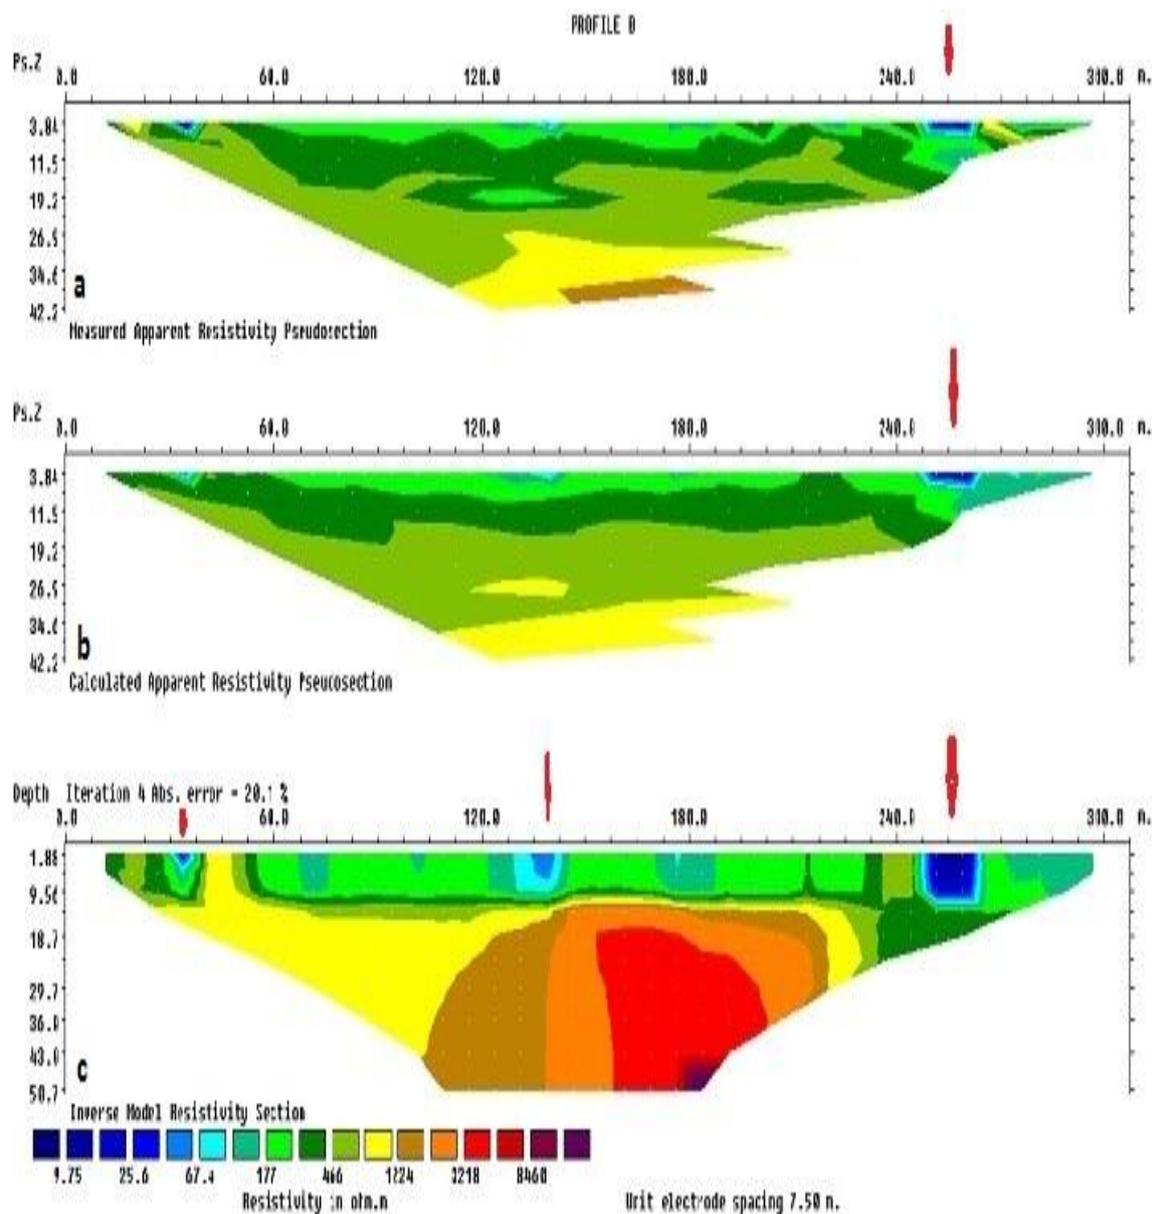
**Figure 4:** Pseudo-section Plot showing (a) measured apparent resistivity of profile B (b) calculated apparent resistivity of profile B (c) inverse model resistivity Section of profile B.

Figure 4(a) is a Pseudo-section from the apparent resistivity measurement along profile B. It shows a low resistivity value ranging from  $25.60 \Omega\text{m}$  –  $67.40 \Omega\text{m}$ , between distances of  $247.50 \text{ m}$  –  $262.50 \text{ m}$  along the profile to a depth of  $7.50 \text{ m}$  from the surface of the profile. Figure 4(b) represents a Pseudo-section established from the calculated apparent resistivity values showing relatively low resistivity values in the same region along the traverse similar to the position of the result obtained in figure 4(a).

Figure 4(c) represents the inverse model showing resistivity sections along the profile B. Several zones along the profile exhibit slightly low resistivity values with most area along the profile having resistivity greater than 200  $\Omega\text{m}$ . Three distinctive zone with very low resistivity values were observed at a distances ranging from 30.0 m – 37.50 m, 135 m – 142.50 m and 247.50 m – 277.50 m to a depth of 3.84 m, 9.54 m and 11.25 respectively.
